Position of the rubber grip on golf clubs

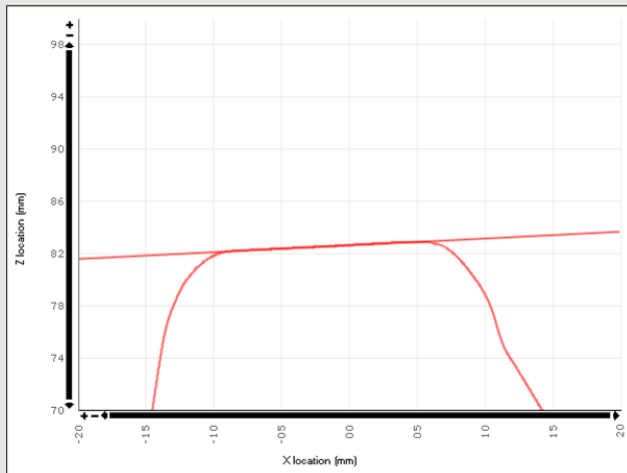
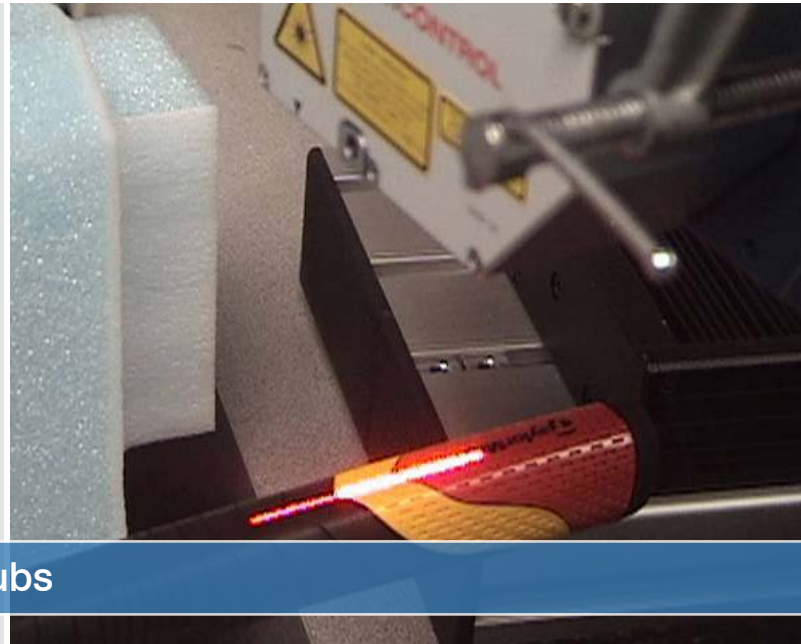
scanCONTROL is used in production for this type of inspection. The rubber grip is moved at right angles to the laser line. The condition of the rubber can be determined from the measured profiles.

scanCONTROL functions completely without making contact with the target surface. Therefore, the rubber is not damaged during measurements, which can occur if contact measurement methods are used. A special housing protects the optical system against dust and other airborne contaminants. The scanner is connected to a PC via a FireWire interface. A customer-specific software application on the PC enables evaluation of results.
